ARLINGTON LAKE DAM  
PENNSYLVANIA

NDI ID PA 00321

PHASE I INSPECTION REPORT  
NATIONAL DAM INSPECTION PROGRAM

August 1981

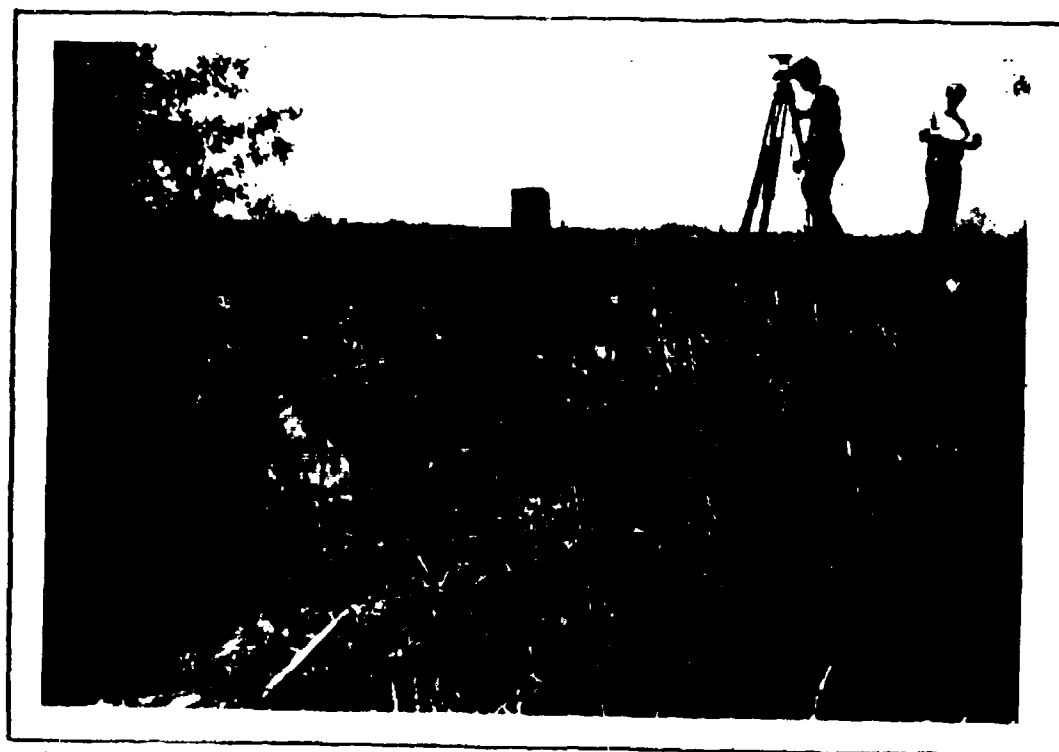
10. VIEW OF THE DOWNSTREAM RETAINING WALL, THROUGH WHICH  
THE OUTLET CONDUIT EMERGES, SHOWING LARGE STRUCTURAL  
CRACKS. (5/5/81)
